Driving Excellence in Workplace Safety & Health (WSH)

Case Study: Stars Engrg Pte Ltd

24 February 2021

Tuas, Singapore

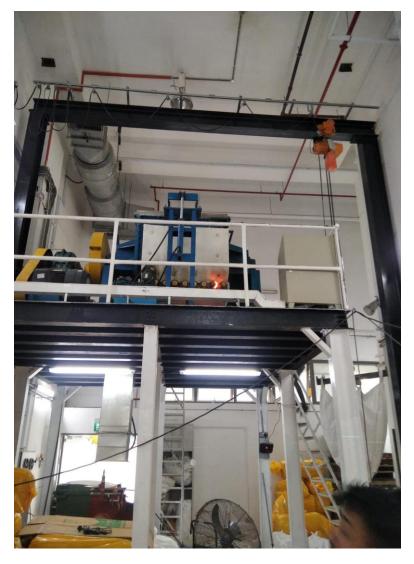
Heating coil fault observed (glowing flange)

- Employer contacted
- Employer gave instruction to shut down machine to replace faulty heating coil

- 1st Explosion and Flash Fire occurred
- Minutes later, explosions and pockets of flash fire occurred
- SCDF arrived
- > Fire extinguished

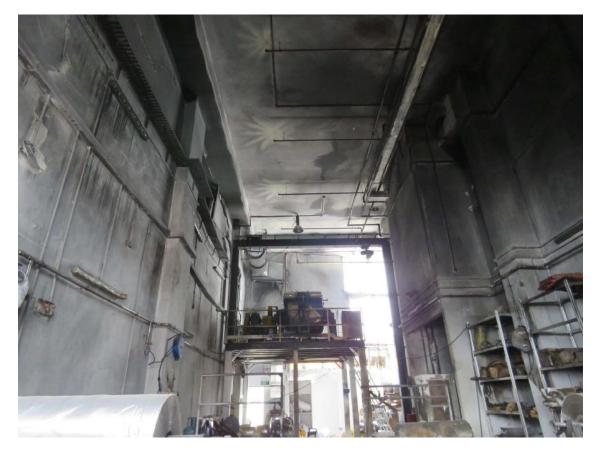
- Mixer machine was used in overheated conditions as a closed system, leading to mechanical rupture
- Oil vapour was expelled and subsequently ignited due to the sudden rupture, leading to the <u>primary</u> <u>explosion</u> and the <u>subsequent secondary flash fires.</u>
- Secondary flash fires were most likely due to the combustion of potato starch powders.

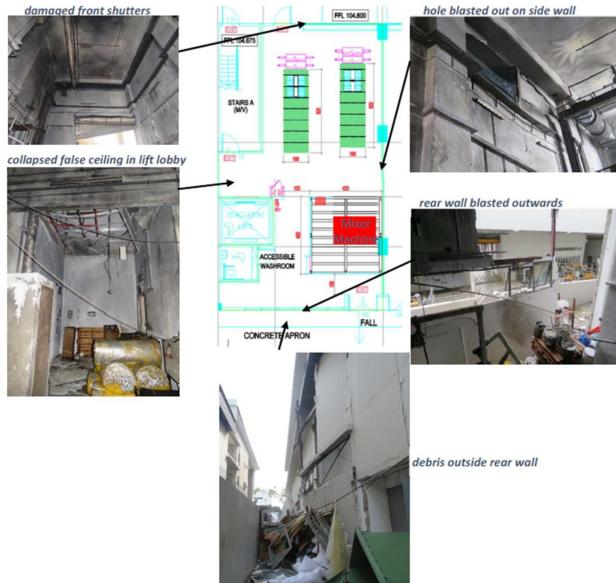
Explosion caused by unsafe use of mixer machine

Temperature within oil jacket was not monitored

Temperature sensors that came with machine to specifically measure and regulate temperature within the oil jacket not properly used

Insufficient thermic oil used in mixer machine's oil jacket

This caused inefficient heat transfer & overheating of the thermic oil. Temperature of thermic oil went beyond its safe operating temperature, leading to thermal degradation, thus reducing its flash point

Mixer machine used as a closed system

Sealing off two vents and no monitoring of pressure within oil jacket led pressure to build up beyond safe levels in the oil jacket

Oil jacket's integrity compromised by poor welding repairs

The repeated heating and cooling cycles with each operation stressed the oil jacket's integrity, causing it to lose its mechanical strength. Poor quality repair welds resulted in welds fracturing and the oil jacket ruptured outwards at weak points
