Driving Excellence in Workplace Safety & Health (WSH)

Case Study: Stars Engrg Pte Ltd

24 February 2021

Tuas, Singapore

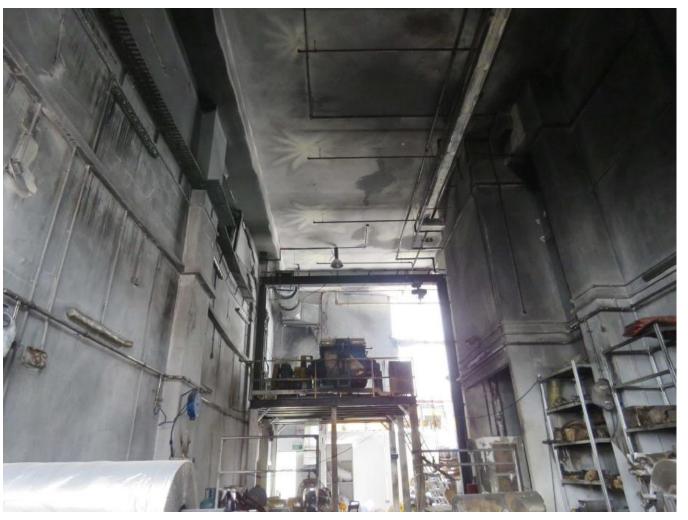
3 fatalities, 7 injuries

Source: Report of the Inquiry Committee for the accident at Stars Engrg Pte Ltd on 24 Feb 2021

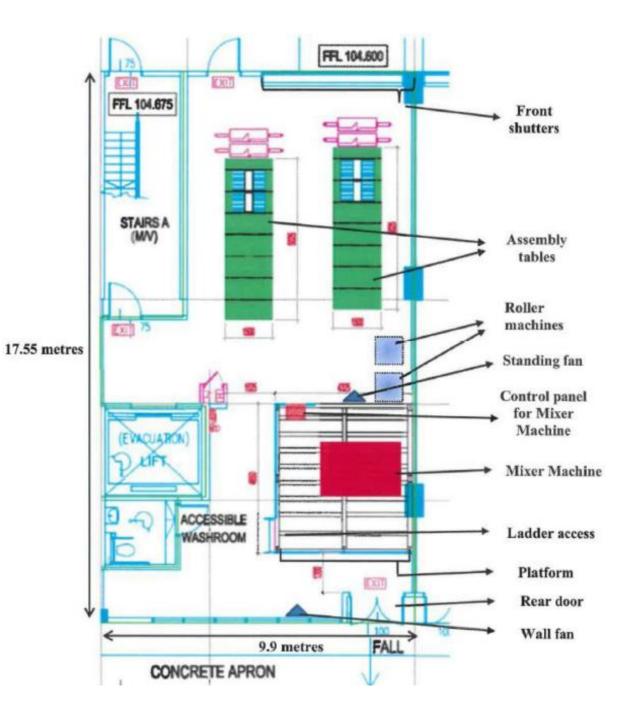
- The worksite measured about 17.55m by 9.90m
- Mixer machine and its control panel was placed on a raised platform
- 2 roller machines were located between the assembly tables and the platform
- 2 assembly tables were placed near the front shutters

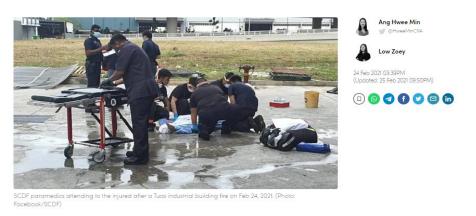
10 people suffer burns after 'loud explosion' at Tuas industrial building

SINGAPORE: Ten people were taken to hospital with burns on Wednesday (Feb 24), following what witnesses say was a "loud explosion" at an industrial building in Tuas.

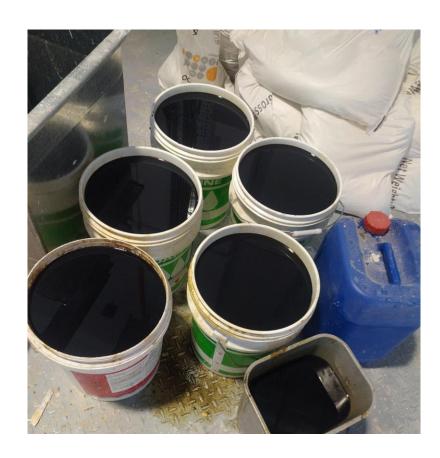
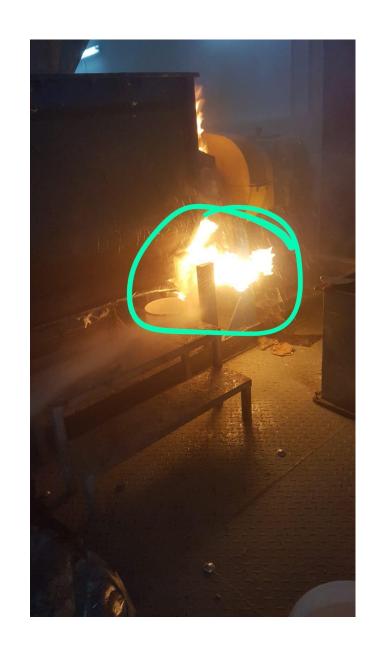
#	Red flags	Implications	What should have been done
1	Blackened oil drained from the oil jacket	Oil has been overheated leading to degradation.	Use the temperature sensor to measure and regulate the oil jacket temperature
2	Boiling sounds heard during operation of the machine		within 200°C. Use sufficient oil (240L) to heat the machine.
3	White smoke coming out of the oil jacket	Pressure is building up within the oil jacket	Operate the machine as an open system
4	Visible cracks seen on the oil jacket	Integrity of the oil jacket has been compromised	
5	Heaters melted / glowed red / caught fire	Heater has overheated (expert: the heaters must have been at temperature above 700°C over a long time)	Use the temperature sensor to measure and regulate the oil jacket temperature within 200°C
